CUSTOMER SERVICES
TELE-NEWS

FILE: Service and Parts No. 95

SUBJECT: Compatibility of Onan solid state, 3-wire and 4-wire, start-stop controls and Walbro Corporation electric fuel pumps.

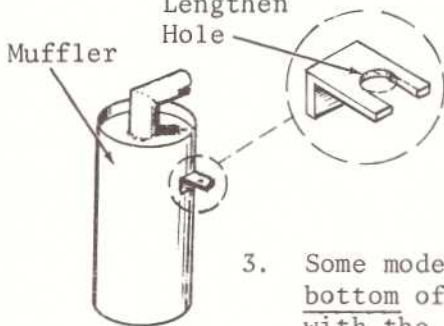
Muffler

2. Metallic Knock(s). The normal starting and stopping torque reaction (turning motion) could cause metal to metal contact.

- b. The muffler can strike the lower air baffle plate when the muffler is not centered in the hole through the plate. To aid in the centering adjustment, change the round hole in the muffler mounting bracket to a lengthwise slot.

Lengthen
Hole
