## LWR A-Arm & Bushings' Removal Step-by-Step Summary by Mike Kordas

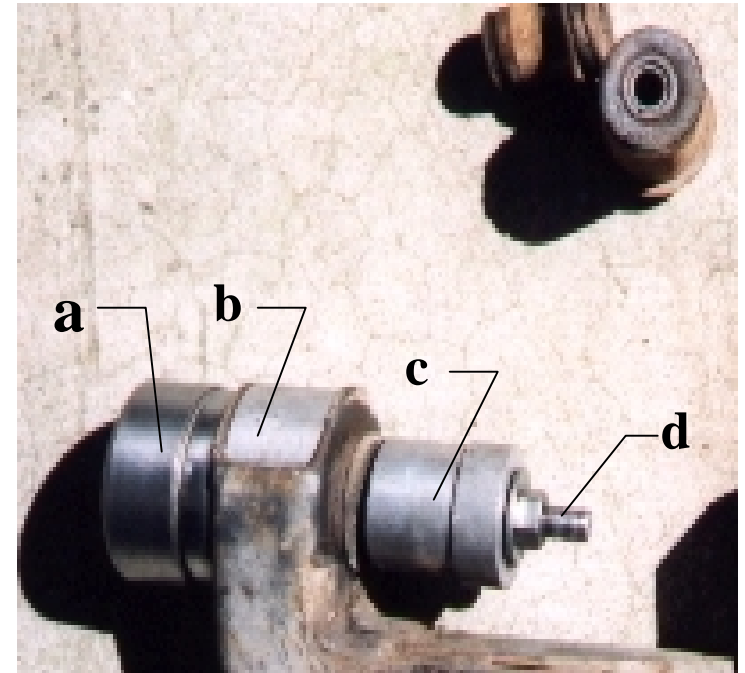
- An air impact wrench and bushing tool, similar to the one shown, help during bushings' removal (**a.** Front brake caliper piston, **b.** 120-180deg pipe segment for A-Arm-flange spacer, **c.** stock aluminum bars for pushers, **d.** long bolt with washers & nut .).
